WHITEFISH BAY SCHOOL DISTRICT

FACILITIES CONDITION ASSESSMENT

FACILITIES ADVISORY COMMITTEE | JANUARY 16, 2025

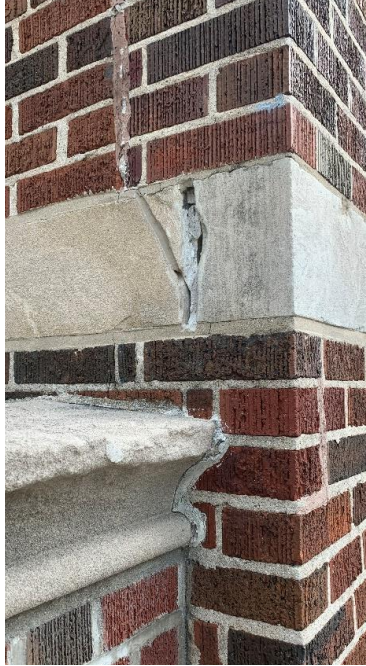
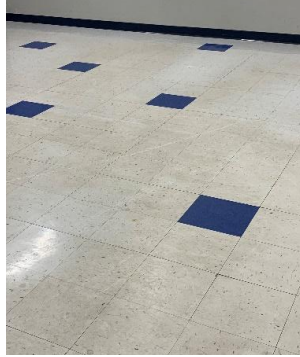
- EXTERIOR MATERIALS
 - Foundation and brick cracking, water damage on bricks and stone, missing mortar in various places
(Yearly district maintenance/tuckpointing)
- INTERIOR MATERIALS
 - VCT floors were installed over multiple layers of floor/sub-floor, over original wood floor on sleepers causing VCT to peel up
(District addressing in phased approach)

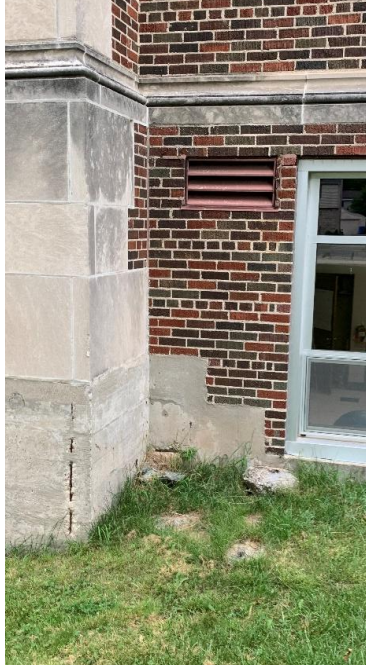
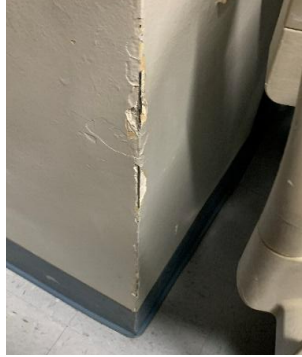
- ACCESSIBILITY ISSUES
 - No accessible entry at front door (through Great Hall)
 - Nearly all door hardware is older knob style, not levers
 - Most classroom entrances have pull/push clearance issues
- INTERIOR MATERIALS (FLOOR/CEILING/CASEWORK)
 - Casework (cabinets) and lockers are nearing lifespan/damaged
 - Doors and frames are largely in poor condition/worn
- EXTERIOR MATERIALS
 - Windows are starting to show signs of age and replacement parts are no longer available (in original building)
- SITE ISSUES
 - Heaving/damaged paving
 - Site has areas of drainage issues

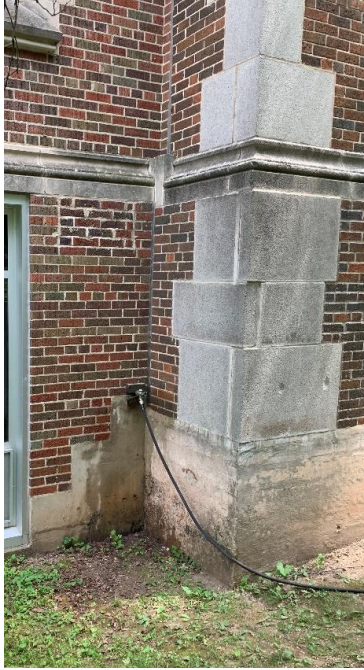
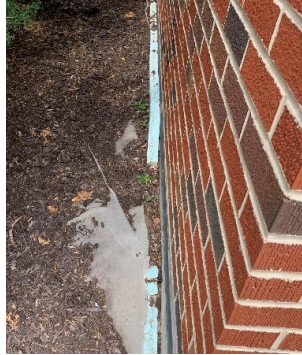
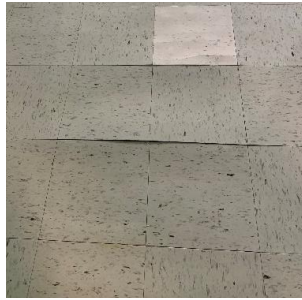
- EXTERIOR MATERIALS
 - Foundation and brick cracking, water damage on bricks and stone, missing mortar in various places
(Yearly district maintenance/tuckpointing)
- INTERIOR MATERIALS
 - VCT floors were installed over multiple layers of floor/sub-floor, over original wood floor on sleepers causing VCT to peel up
(District addressing in phased approach)

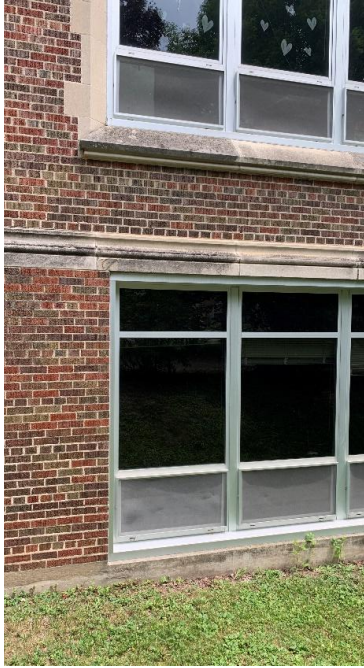
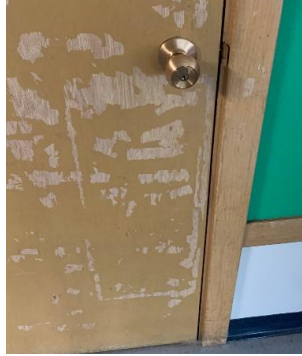
- **ACCESSIBILITY ISSUES**
 - No accessible entry at front door (through Great Hall)
 - Nearly all door hardware is older knob style, not levers
 - Some classroom entrances have pull/push clearance issues
- **INTERIOR MATERIALS (FLOOR/CEILING/CASEWORK)**
 - Casework (cabinets) and lockers are nearing lifespan/damaged
 - Doors and frames are largely in poor condition/worn
- **EXTERIOR MATERIALS**
 - Windows are starting to show signs of age and replacement parts are no longer available (in original building)
- **SITE ISSUES**
 - Heaving/damaged paving

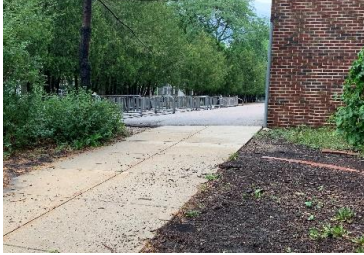
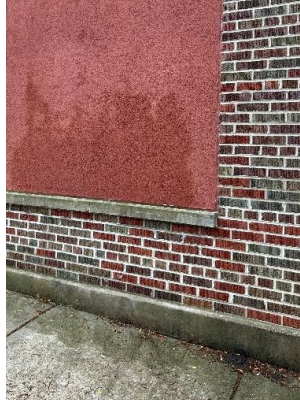
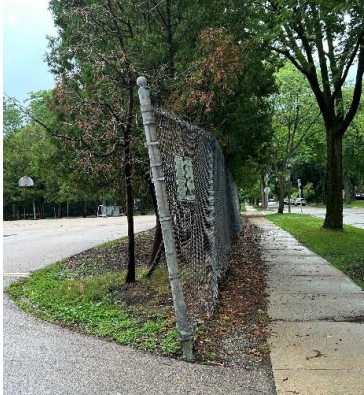
- EXTERIOR MATERIALS
 - Damaged exterior materials, including brick and mortar in various places
(Yearly tuckpointing/maintenance)
- SITE ISSUES
 - Constrained space with little to no room for expansion
 - Site pavement cracking
 - Damaged asphalt surrounding the lot and recreation yard
 - Issues of site drainage around building – site drains towards building, areas of ponding, etc.

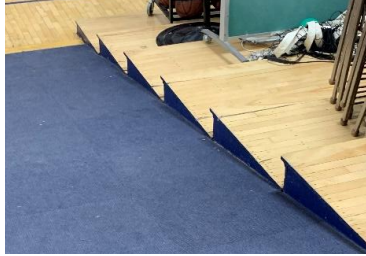
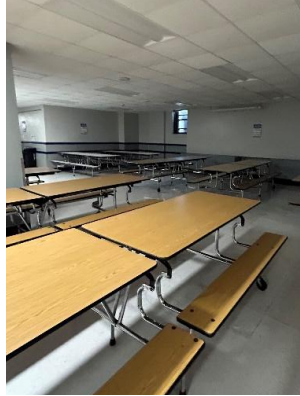
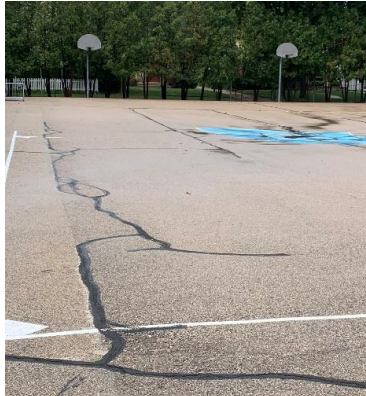
- ACCESSIBILITY
 - Difficult to navigate levels, with areas such as office and old gym accessed through circuitous means
 - Some classroom entrances have pull/push clearance issues
 - Some bathrooms entirely inaccessible
 - Some door hardware is older style knob, not lever
- INTERIOR MATERIALS (FLOOR/CEILING/CASEWORK)
 - Many interior materials are at or nearing expected lifespan
 - Many VCT floors are cracked in corridors and classrooms
 - Doors and frames are largely in poor condition/worn
- EXTERIOR MATERIALS
 - Brick trim and EFIS panels are aged/worn
 - Windows are starting to show signs of age/wear

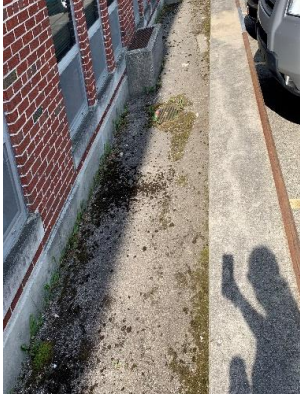
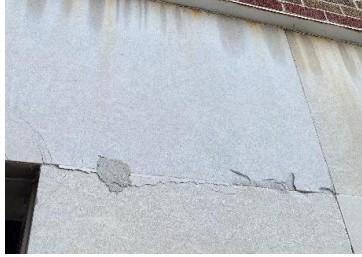
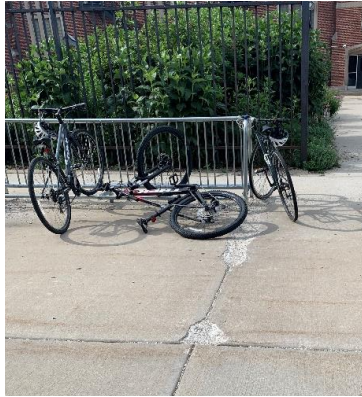
- EXTERIOR MATERIALS
 - Damaged exterior materials, including brick and mortar
(Yearly tuckpointing/maintenance)
- INTERIOR MATERIALS
 - Some known leaks (from HVAC) with ceilings replaced as needed
- SITE ISSUES
 - Site pavement cracking/spalling
 - Known areas of poor drainage that are regularly monitored

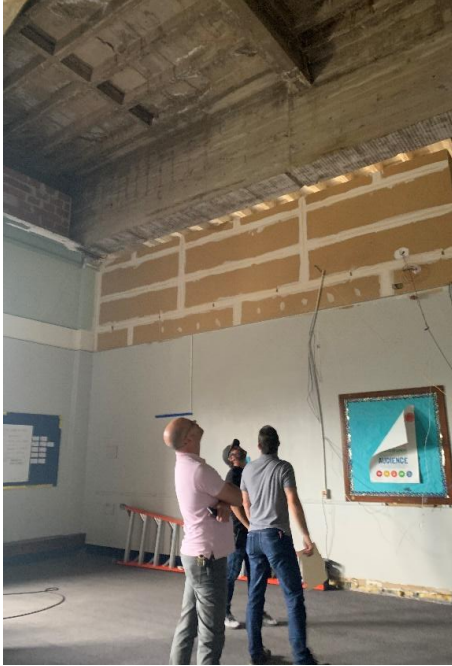
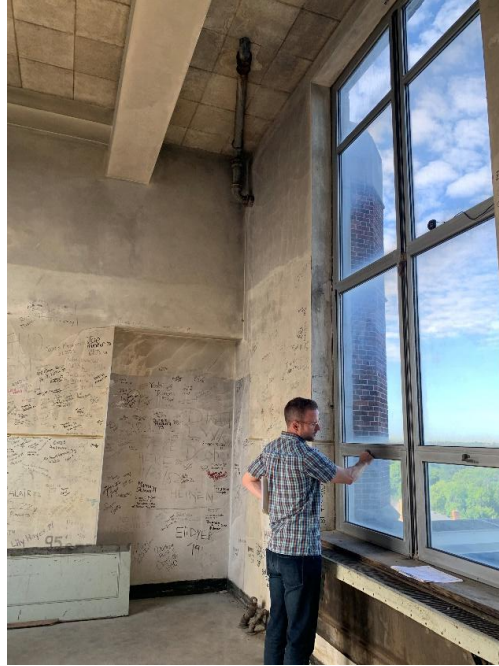
WHITEFISH BAY HIGH SCHOOL – BELL TOWER

- Method of construction around bell tower causes reoccurring leaks/damage
- District is remedying to best of ability, but leaks are likely to reoccur (as have happened with roofing improvements in the past)

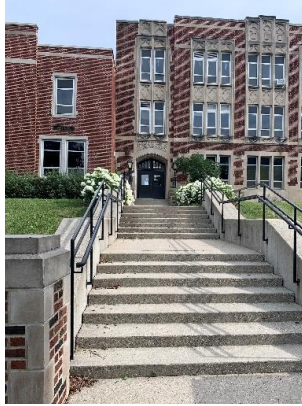
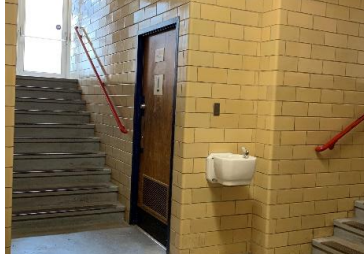
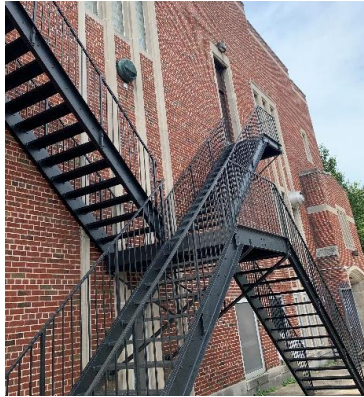
- Majority of lower level is inaccessible or difficult to maneuver with no access to fieldhouse locker rooms (tunnel)
- Memorial gym balcony is inaccessible
- Old pool (and associated locker rooms) does not have an entrance with maneuvering clearances
- Older forms of egress (fire escapes) are not accessible
- Many classroom entrances have pull/push clearance issues
- Most door hardware older style knobs, not levers

- Damaged/worn materials in corridors and classrooms
- Many flooring and ceiling tiles need to be replaced
- Doors and frames are largely in poor condition/worn

- Site pavement heaving / cracking
- Site and athletic fencing is in poor condition/listing in some areas

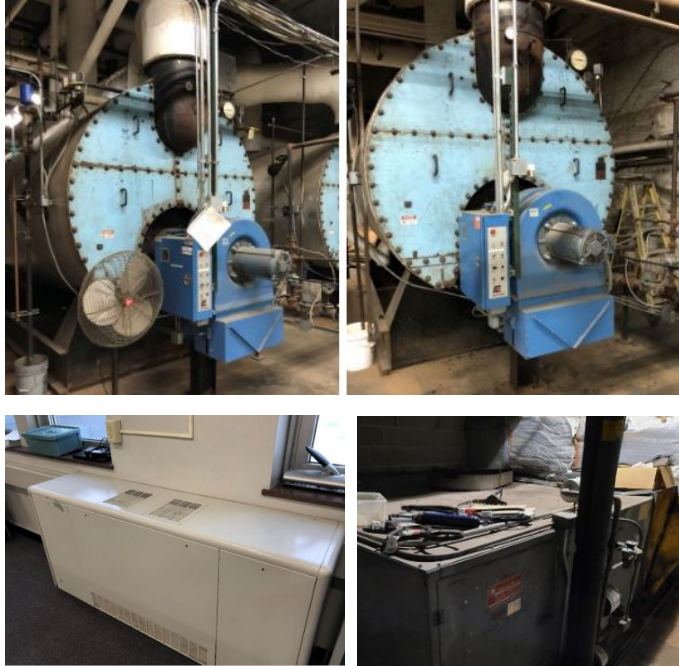
- Steam boilers dating back to 1957 well past life expectancy
- Unit ventilators in classrooms loud, maintenance intensive and lack cooling.
- Replace pneumatic controls system with full DDC
- Replace chillers and air handlers, some nearly 70 years old

- Replace galvanized domestic water piping throughout

- Upgrade electrical distribution throughout building to accommodate today's device demands.

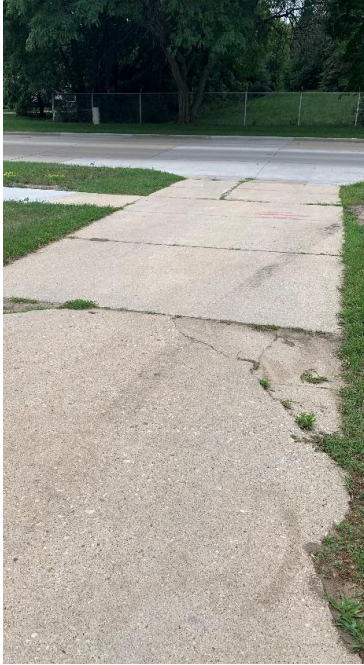
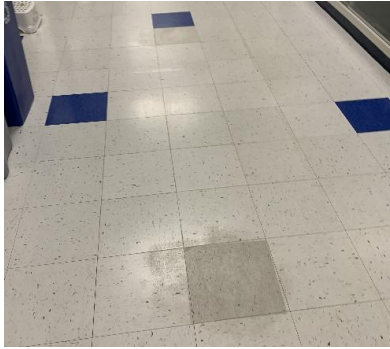
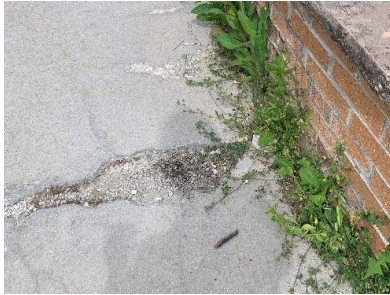
- INTERIOR MATERIALS
 - District addressing flooring updates
- SITE ISSUES
 - Areas of asphalt and concrete are heaving and/or cracking

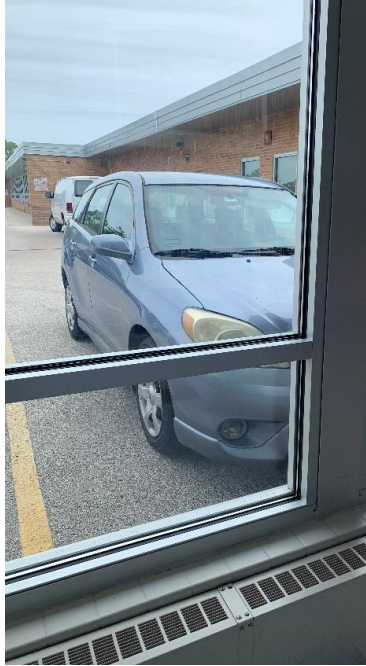
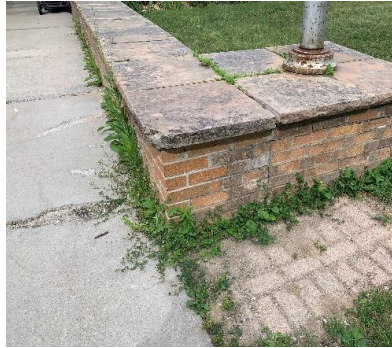
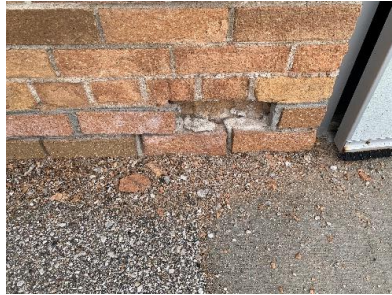
- INTERIOR MATERIALS (FLOOR/CEILING)
 - Some interior materials are at or nearing expected lifespan
 - Humidity has caused issues with ceiling tiles + gym floor (bowing)
- EXTERIOR MATERIALS
 - Brick near base of wall around much of the building is spalling/crumbling, likely from salt against building
- SITE ISSUES
 - Areas of asphalt and concrete are heaving and/or cracking
 - No vehicular protection (bollards or wheel stops) around much of the building
 - Site walls and some fencing are damaged/listing
