WHITEFISH BAY SCHOOL DISTRICT

COMMUNITY SESSION #2
OVERVIEW + HIGH SCHOOL
November 1, 2023

Facilities Condition Assessment

WHITEFISH BAY SCHOOL DISTRICT
LONG RANGE FACILITIES MASTER PLAN

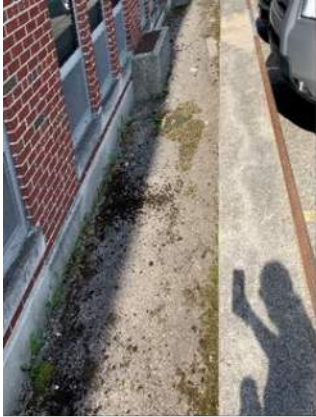
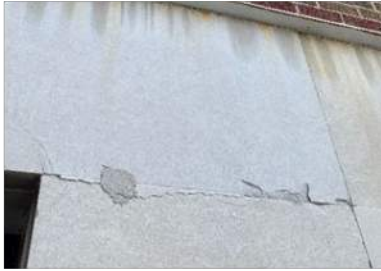
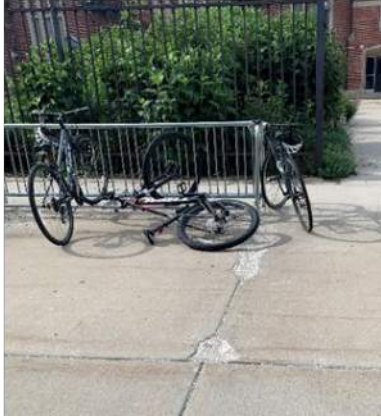
WHITEFISH BAY HIGH SCHOOL ONGOING MAINTENANCE

- **EXTERIOR MATERIALS**

- Damaged exterior materials, including brick and mortar
(Yearly tuckpointing/maintenance)

- **INTERIOR MATERIALS**

- Some known leaks (from HVAC) with ceilings replaced as needed

- **SITE ISSUES**

- Site pavement cracking/spalling
- Known areas of poor drainage that are regularly monitored

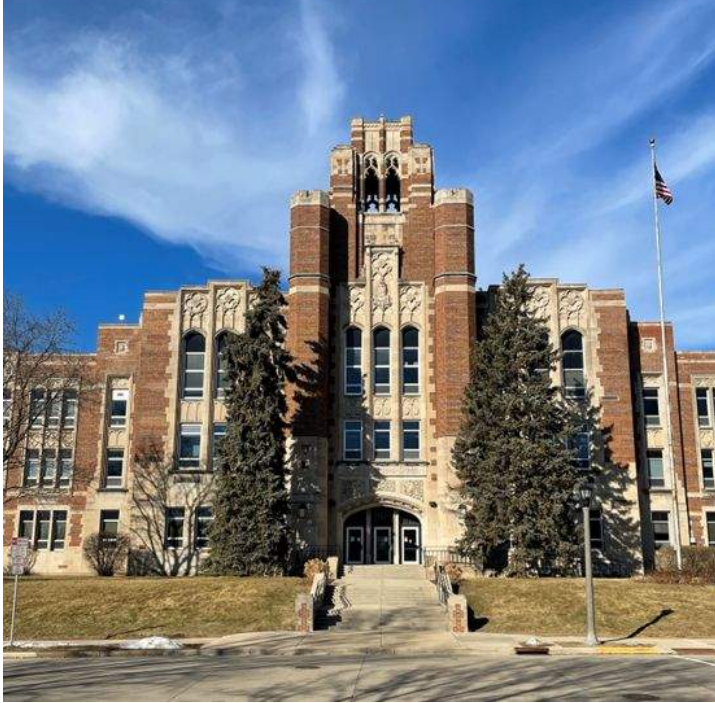
WHITEFISH BAY HIGH SCHOOL - BELL TOWER

- **ONGOING ISSUES**

- Method of construction around bell tower causes recurring leaks/damage
- District is remedying to best of ability, but leaks are likely to reoccur (as have happened with roofing improvements in the past)

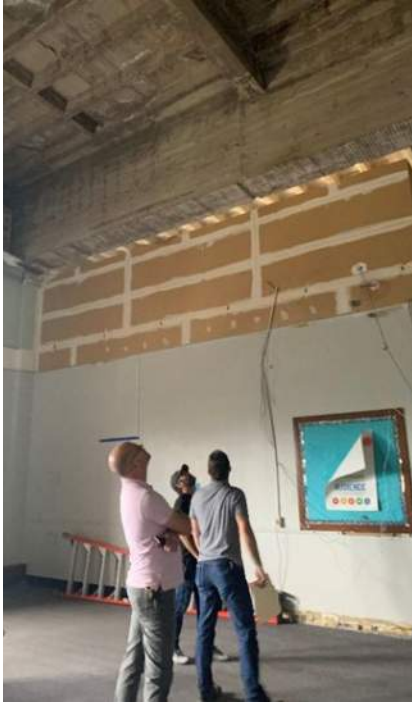
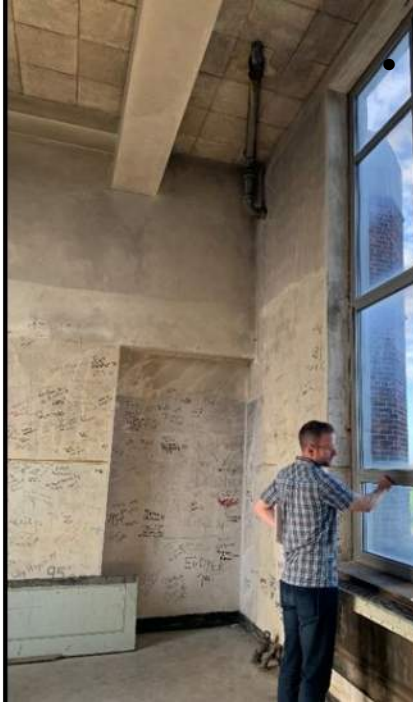
WHITEFISH BAY HIGH SCHOOL - BELL TOWER

ONGOING ISSUES

- Method of construction around bell tower causes recurring leaks/damage
- District is remedying to best of ability, but leaks are likely to reoccur (as have happened with roofing improvements in the past)

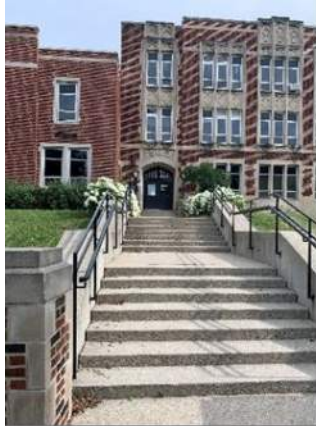
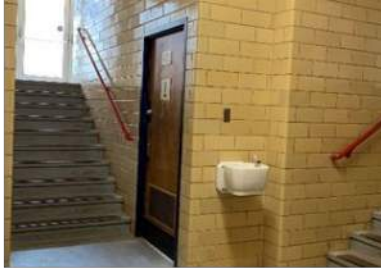
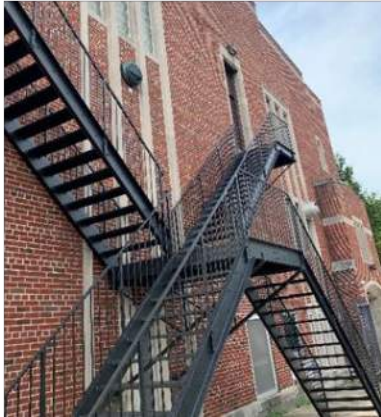
WHITEFISH BAY HIGH SCHOOL - MAINTENANCE OVERVIEW

- **ACCESSIBILITY ISSUES**

- Majority of lower level is inaccessible or difficult to maneuver with no access to fieldhouse locker rooms (tunnel)
- Memorial gym balcony is inaccessible
- Old pool (and associated locker rooms) does not have an entrance with maneuvering clearances
- Older forms of egress (fire escapes) are not accessible
- Many classroom entrances have pull/push clearance issues
- Most door hardware older style knobs, not levers

- **INTERIOR MATERIALS (FLOOR/CEILING/CASEWORK)**

- Damaged/worn materials in corridors and classrooms
- Much of the flooring and ceiling tiles need to be replaced
- Doors and frames are largely in poor condition/worn

- **SITE ISSUES**

- Site + athletic fencing is in poor condition/listing in some areas

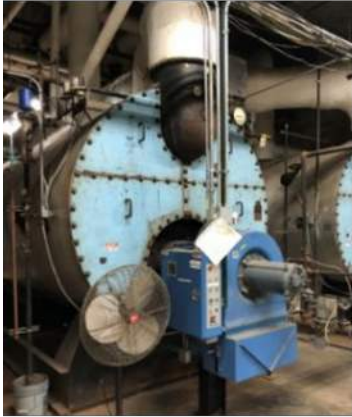
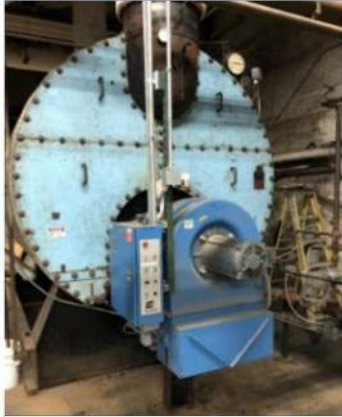
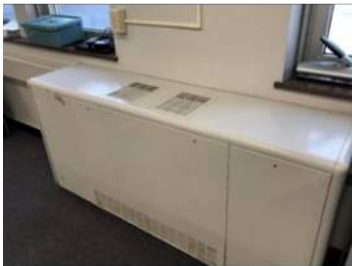
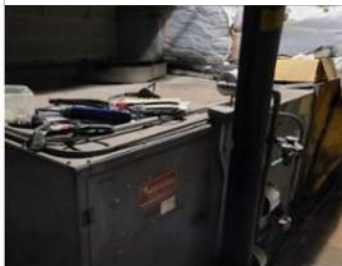
WHITEFISH BAY HIGH SCHOOL MAINTENANCE OVERVIEW

- **MECHANICAL SYSTEMS**

- Steam boilers dating back to 1957 well past life expectancy
- Unit ventilators in classrooms loud, maintenance intensive and lack cooling.
- Building has dated pneumatic controls system
- Chillers and air handlers need to be replaced, some are nearly 70 years old

- **PLUMBING SYSTEMS**

- Replace galvanized domestic water piping throughout

- **ELECTRICAL SYSTEMS**

- Electrical distribution needs to be upgraded to accommodate device demands
