WHITEFISH BAY SCHOOL DISTRICT

LONG RANGE FACILITIES MASTER PLANNING

October 18, 2023

Facilities Condition Assessment

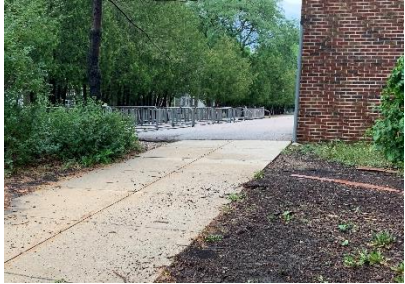
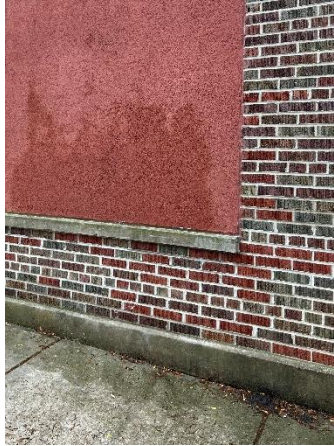
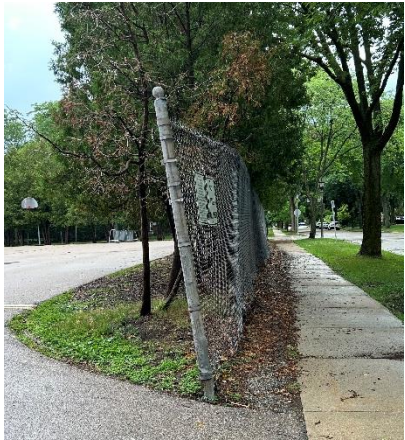
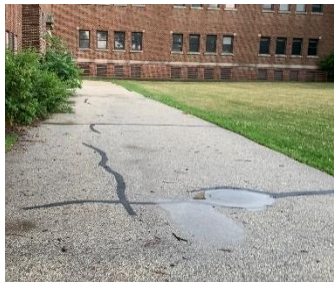
• EXTERIOR MATERIALS

- Damaged exterior materials, including brick and mortar in various places
(Yearly tuckpointing/maintenance)

• SITE ISSUES

- Constrained space with little to no room for expansion
- Site pavement cracking
- Damaged asphalt surrounding the lot and recreation yard
- Issues of site drainage around building – site drains towards building, areas of ponding, etc.

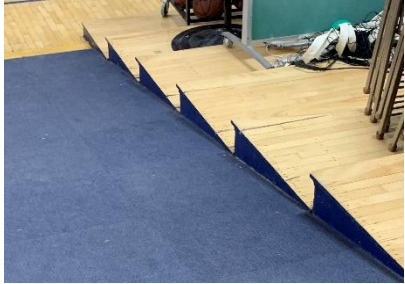
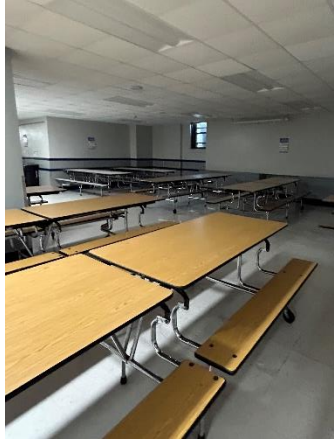
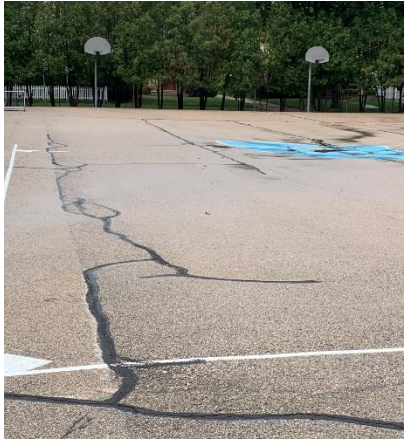
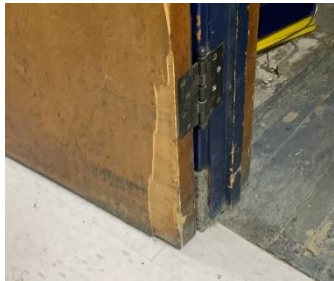
- **ACCESIBILITY**

- Difficult to navigate levels, with areas such as office and old gym accessed through circuitous means
- Some classroom entrances have pull/push clearance issues
- Some bathrooms entirely inaccessible
- Some door hardware is older style knob, not lever

- **INTERIOR MATERIALS (FLOOR/CEILING/CASEWORK)**

- Many interior materials are at or nearing expected lifespan
- Many VCT floors are cracked in corridors and classrooms
- Doors and frames are largely in poor condition/worn

- **EXTERIOR MATERIALS**

- Brick trim and EFIS panels are aged/worn
- Windows are starting to show signs of age/wear

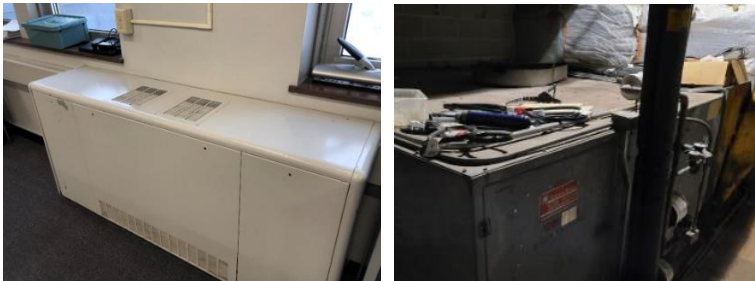
- **MECHANICAL SYSTEMS**

- Steam boilers dating back to 1957 well past life expectancy
- Unit ventilators in classrooms loud, maintenance intensive and lack cooling.
- Replace pneumatic controls system with full DDC
- Replace chillers and air handlers, some nearly 70 years old

- **PLUMBING SYSTEMS**

- Replace galvanized domestic water piping throughout

- **ELECTRICAL SYSTEMS**

- Upgrade electrical distribution throughout building to accommodate today's device demands.
