WHITEFISH BAY SCHOOL DISTRICT

FACILITIES CONDITION ASSESSMENT

FACILITIES ADVISORY COMMITTEE | JANUARY 16, 2025

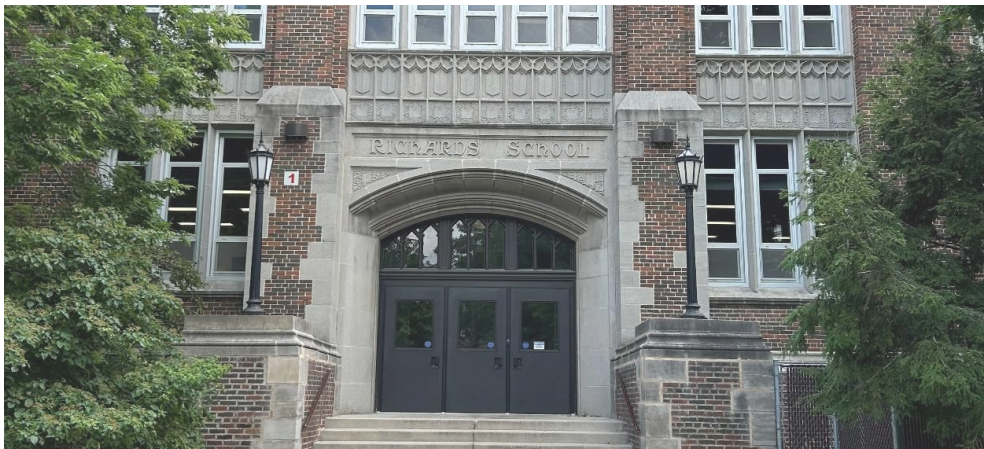
RICHARDS ELEMENTARY OVERVIEW

- EXTERIOR MATERIALS
 - Foundation and brick cracking, water damage on bricks and stone, missing mortar in various places
(Yearly district maintenance/tuckpointing)
- INTERIOR MATERIALS
 - VCT floors were installed over multiple layers of floor/sub-floor, over original wood floor on sleepers causing VCT to peel up
(District addressing in phased approach)

- **ACCESSIBILITY ISSUES**
 - No accessible entry at front door (through Great Hall)
 - Nearly all door hardware is older knob style, not levers
 - Some classroom entrances have pull/push clearance issues
- **INTERIOR MATERIALS (FLOOR/CEILING/CASEWORK)**
 - Casework (cabinets) and lockers are nearing lifespan/damaged
 - Doors and frames are largely in poor condition/worn
- **EXTERIOR MATERIALS**
 - Windows are starting to show signs of age and replacement parts are no longer available (in original building)
- **SITE ISSUES**
 - Heaving/damaged paving

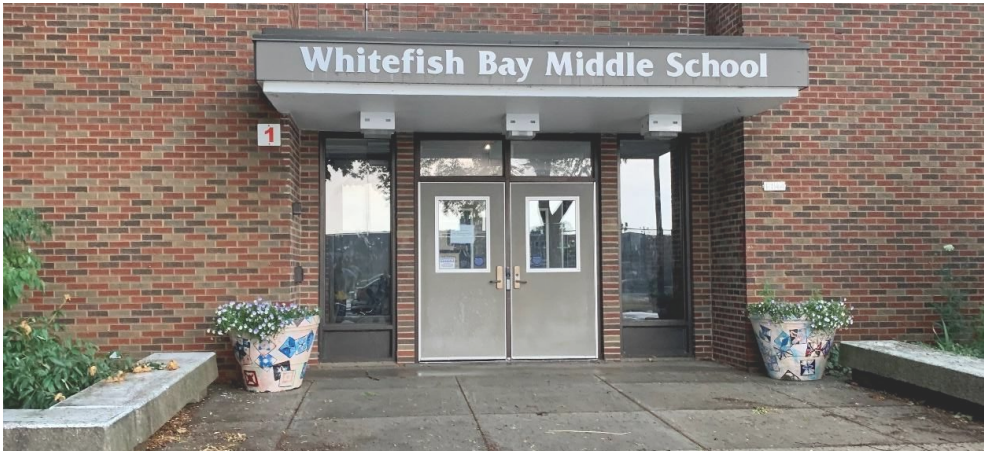
WHITEFISH BAY MIDDLE SCHOOL OVERVIEW

- EXTERIOR MATERIALS
 - Damaged exterior materials, including brick and mortar in various places
(Yearly tuckpointing/maintenance)
- SITE ISSUES
 - Constrained space with little to no room for expansion
 - Site pavement cracking
 - Damaged asphalt surrounding the lot and recreation yard
 - Issues of site drainage around building – site drains towards building, areas of ponding, etc.

- ACCESSIBILITY
 - Difficult to navigate levels, with areas such as office and old gym accessed through circuitous means
 - Some classroom entrances have pull/push clearance issues
 - Some bathrooms entirely inaccessible
 - Some door hardware is older style knob, not lever
- INTERIOR MATERIALS (FLOOR/CEILING/CASEWORK)
 - Many interior materials are at or nearing expected lifespan
 - Many VCT floors are cracked in corridors and classrooms
 - Doors and frames are largely in poor condition/worn
- EXTERIOR MATERIALS
 - Brick trim and EFIS panels are aged/worn
 - Windows are starting to show signs of age/wear

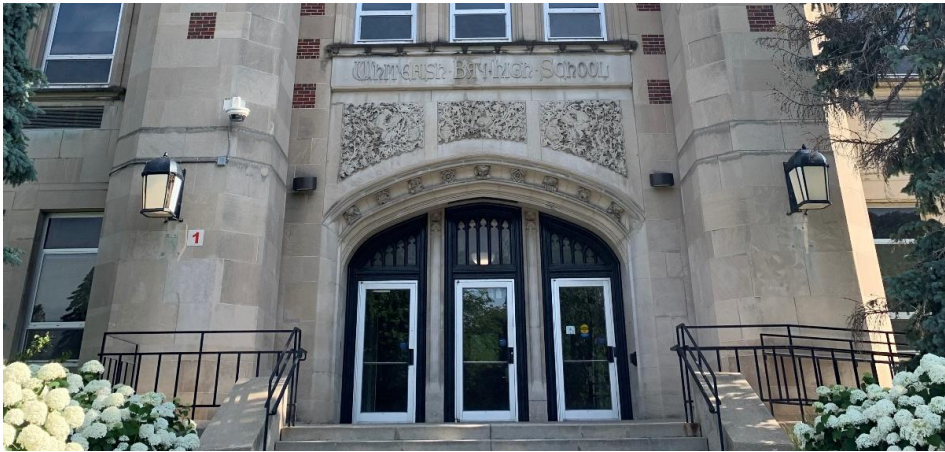
WHITEFISH BAY HIGH SCHOOL OVERVIEW

ACCESSIBILITY	Fair to Poor
SAFETY + SECURITY	Good to Fair
SITE	Fair
EXTERIOR	Fair
INTERIOR	Fair
SYSTEMS	Fair to Poor

- EXTERIOR MATERIALS
 - Damaged exterior materials, including brick and mortar
(Yearly tuckpointing/maintenance)
- INTERIOR MATERIALS
 - Some known leaks (from HVAC) with ceilings replaced as needed
- SITE ISSUES
 - Site pavement cracking/spalling
 - Known areas of poor drainage that are regularly monitored

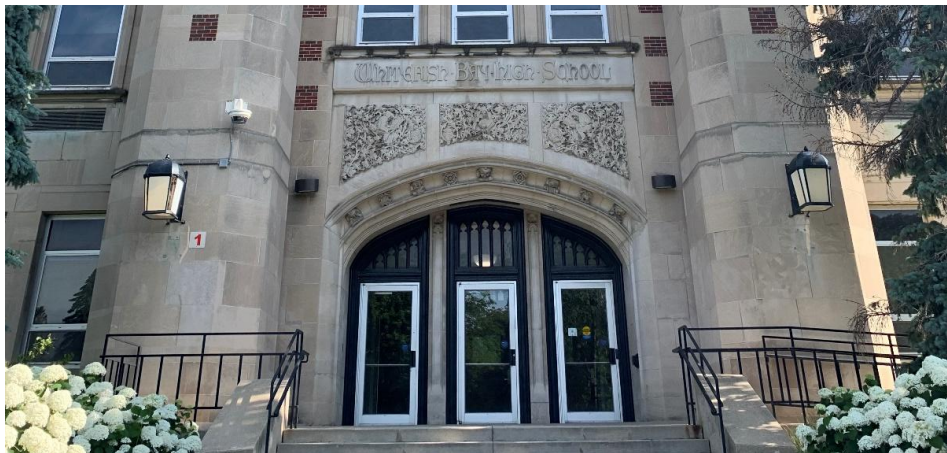
WHITEFISH BAY HIGH SCHOOL OVERVIEW

- Method of construction around bell tower causes reoccurring leaks/damage
- District is remedying to best of ability, but leaks are likely to reoccur (as have happened with roofing improvements in the past)

- Damaged/worn materials in corridors and classrooms
- Many flooring and ceiling tiles need to be replaced
- Doors and frames are largely in poor condition/worn

- Site pavement heaving / cracking
- Site and athletic fencing is in poor condition/listing in some areas

- Steam boilers dating back to 1957 well past life expectancy
- Unit ventilators in classrooms loud, maintenance intensive and lack cooling.
- Replace pneumatic controls system with full DDC
- Replace chillers and air handlers, some nearly 70 years old

- Replace galvanized domestic water piping throughout

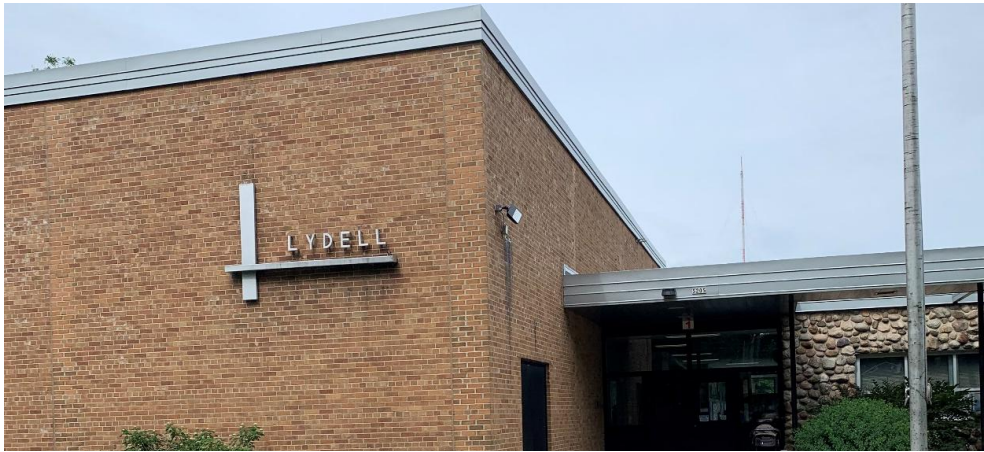
LYDELL COMMUNITY CENTER OVERVIEW

- INTERIOR MATERIALS
 - District addressing flooring updates
- SITE ISSUES
 - Areas of asphalt and concrete are heaving and/or cracking

- INTERIOR MATERIALS (FLOOR/CEILING)
 - Some interior materials are at or nearing expected lifespan
 - Humidity has caused issues with ceiling tiles + gym floor (bowing)
- EXTERIOR MATERIALS
 - Brick near base of wall around much of the building is spalling/crumbling, likely from salt against building
- SITE ISSUES
 - Areas of asphalt and concrete are heaving and/or cracking
 - No vehicular protection (bollards or wheel stops) around much of the building
 - Site walls and some fencing are damaged/listing
