WHITEFISH BAY SCHOOL DISTRICT

FACILITIES MASTER PLANNING UPDATE #3 EXISTING FACILITIES CONDITIONS

September 27, 2023

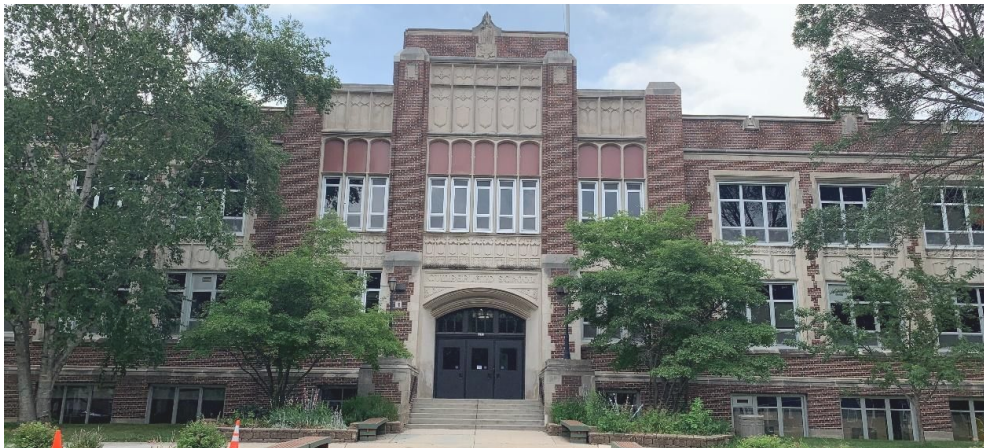
CUMBERLAND ELEMENTARY OVERVIEW

ADDRESS: 4780 N Marlborough Dr, Whitefish Bay, WI 53211

SITE SIZE: 9.1 acres

BUILDING SIZE: 103,918 SF

BUILDING AGE: 1928 (additions in 1950s and 2010)

ACCESSIBILITY	Fair to Poor
SAFETY + SECURITY	Fair
SITE	Good to Fair
EXTERIOR	Fair
INTERIOR	Fair
SYSTEMS	Fair

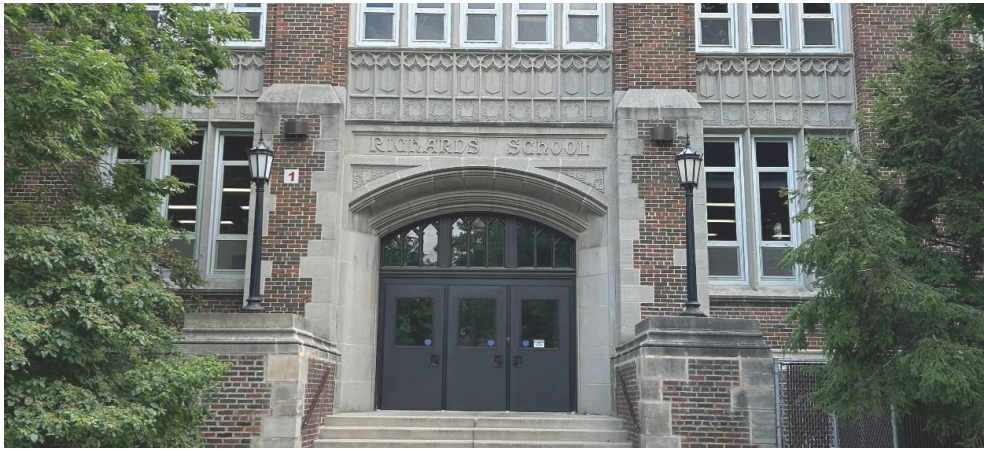
RICHARDS ELEMENTARY OVERVIEW

ADDRESS: 5812 N Santa Monica Blvd, Whitefish Bay, WI 53217

SITE SIZE: 5.5 acres

BUILDING SIZE: 105,256 SF

BUILDING AGE: 1928 (additions in 1950s and 2010)

ACCESSIBILITY	Fair to Poor
SAFETY + SECURITY	Fair
SITE	Fair
EXTERIOR	Fair
INTERIOR	Fair
SYSTEMS	Fair

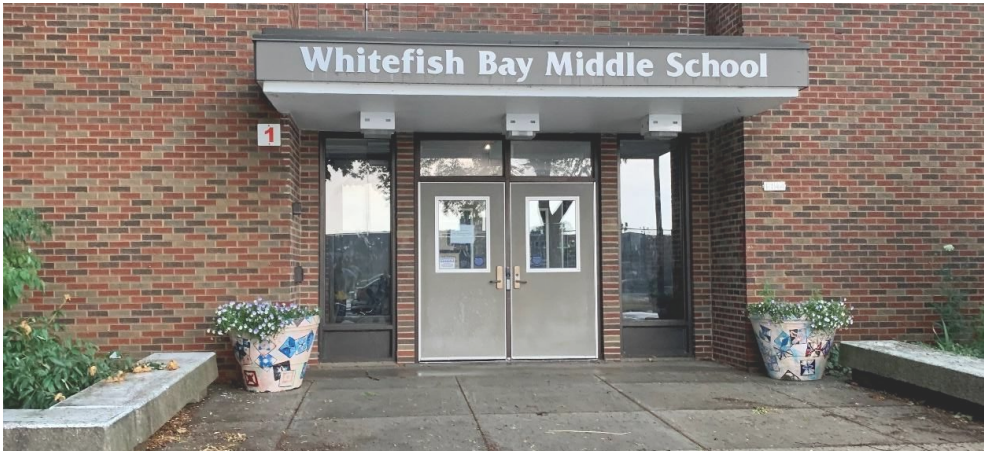
WHITEFISH BAY MIDDLE SCHOOL OVERVIEW

ADDRESS: 1144 E Henry Clay St, Whitefish Bay, WI 53217

SITE SIZE: 2.8 acres

BUILDING SIZE: 127,186 SF

BUILDING AGE: 1918 (additions in 1930s, 1980s, and 1996)

ACCESSIBILITY	Fair to Poor
SAFETY + SECURITY	Fair
SITE	Fair to Poor
EXTERIOR	Fair to Poor
INTERIOR	Fair
SYSTEMS	Fair
